### Cut 400v cable

### Karapiro Hydro Station - Mercury

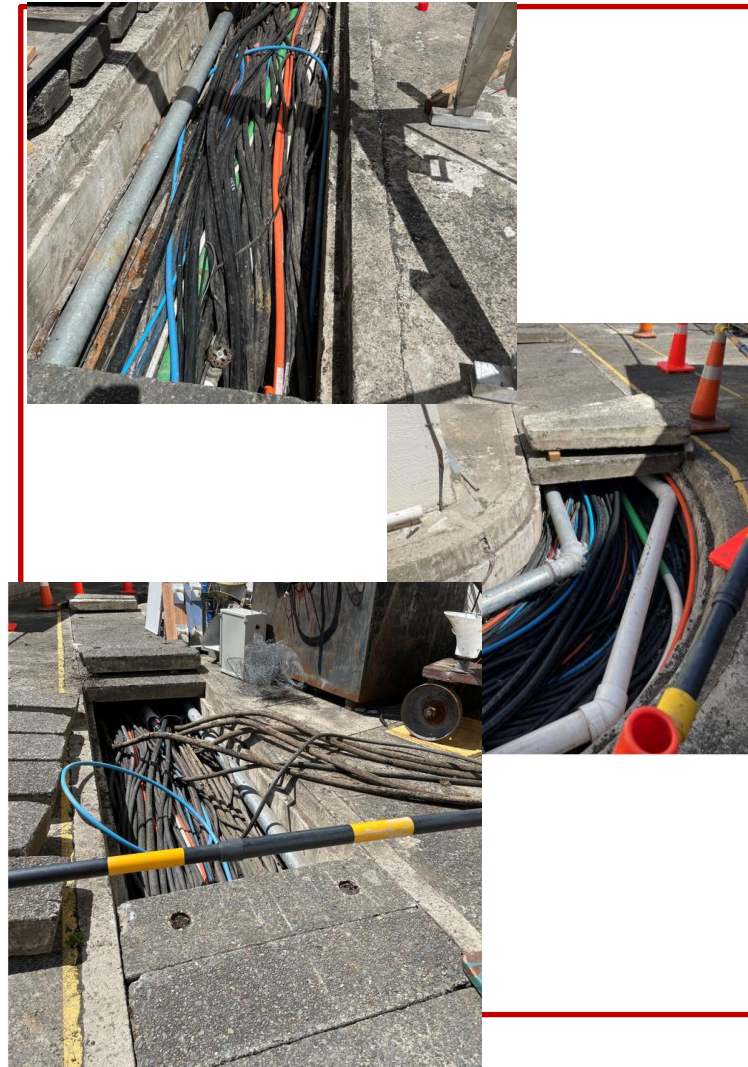
1. The work party was removing redundant cables from a cable trench when they inadvertently cut the wrong (live) cable.
2. The cables were being cut in 2-3 metre lengths and identification was done by a) visual identification b) pulling on the cable to identify it and where (b) wasn't viable then c) tapping on it to create a "vibration" to identify one end of the cable, which ran under concrete lids on top, to the other end of the cable.
3. As the cables had been in situ since 1940 there was a lot of debris making identification of cables difficult. Along with layers of multiple cables.

1. Clearly identify correct redundant cables prior to cutting
2. Use a lifting frame to remove the concrete lids so that the entire cable is visible.
3. Lift the cable to be cut out of the trench prior to cutting to ensure the correct cable is cut.
4. Clearly mark the cable prior to cutting.
5. If cable is still not clearly identifiable use a cable spike following correct safe procedures to prove the cable is de-energised.
