# Safety Alert

1296817-Found damaged equipment has been put back in service.

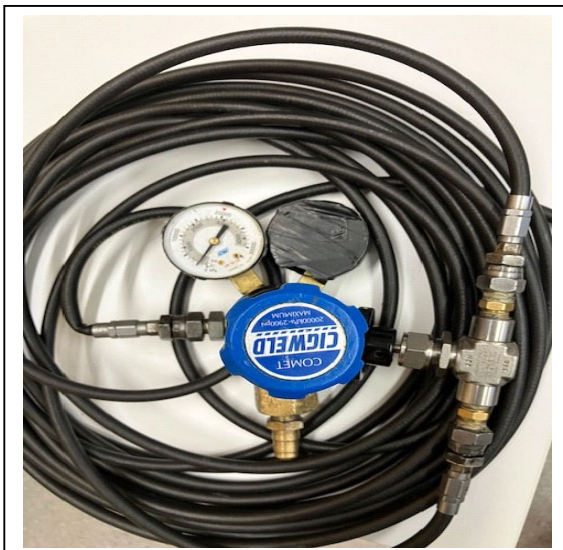
## PHOTO

It was found that the test gear, the hose, and regulator was damaged and was known to be a condemned unit that had already been taken out of service.

- Although discussed that the gear was not suitable for use the gear was not tagged.
- The gear was left on the bench and not placed in the quarantine bin.
- It was believed the physical state of the equipment showed it was not fit for use.

- Put a stop to the accumulator checks.
- Faulty equipment disassembled and thrown out for second time.

Always use an Out of Order tag when discarding gear or alternatively destroy the gear beyond repair.
