Shared Learning

Geothermal Fluid | Steam Hammer leading to LOPC | Rotokawa site

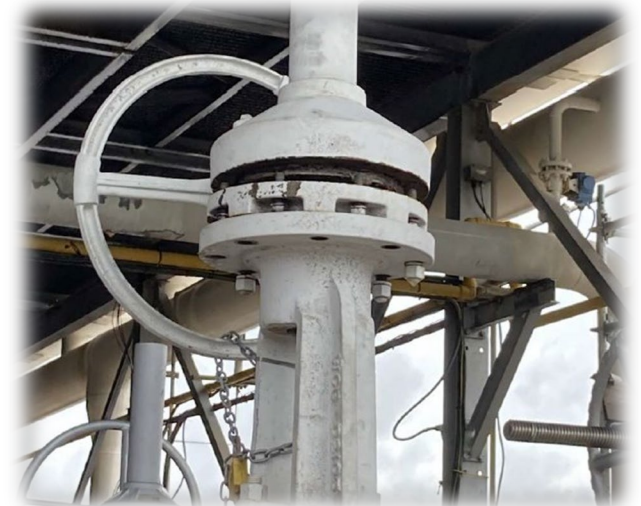
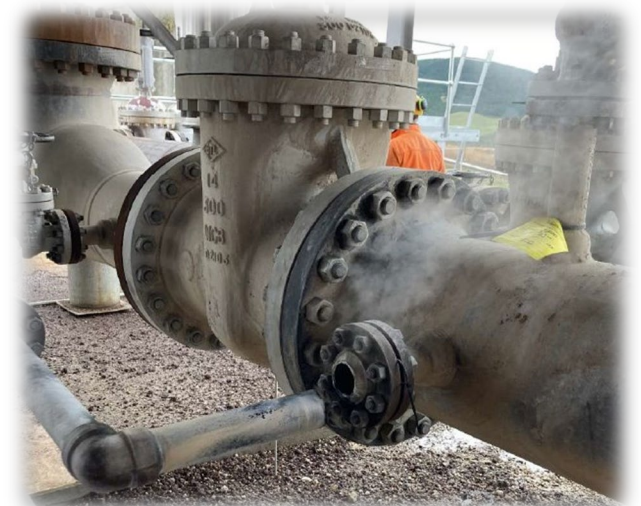
The incident damaged pipework and released steam to the surrounding area.

Due to low reinjection back pressure, hot brine started to flash and generated large quantities of steam.

Mixing of hot steam with subcooled brine led to ongoing 'Condensation Induced Water Hammer' (CIWH) that ultimately led to pipework damage and loss of containment of steam.

We should not have relied on single isolation, but should have used spading or double block and bleed

We should have immediately shut down the station when the loss of containment of steam was detected.

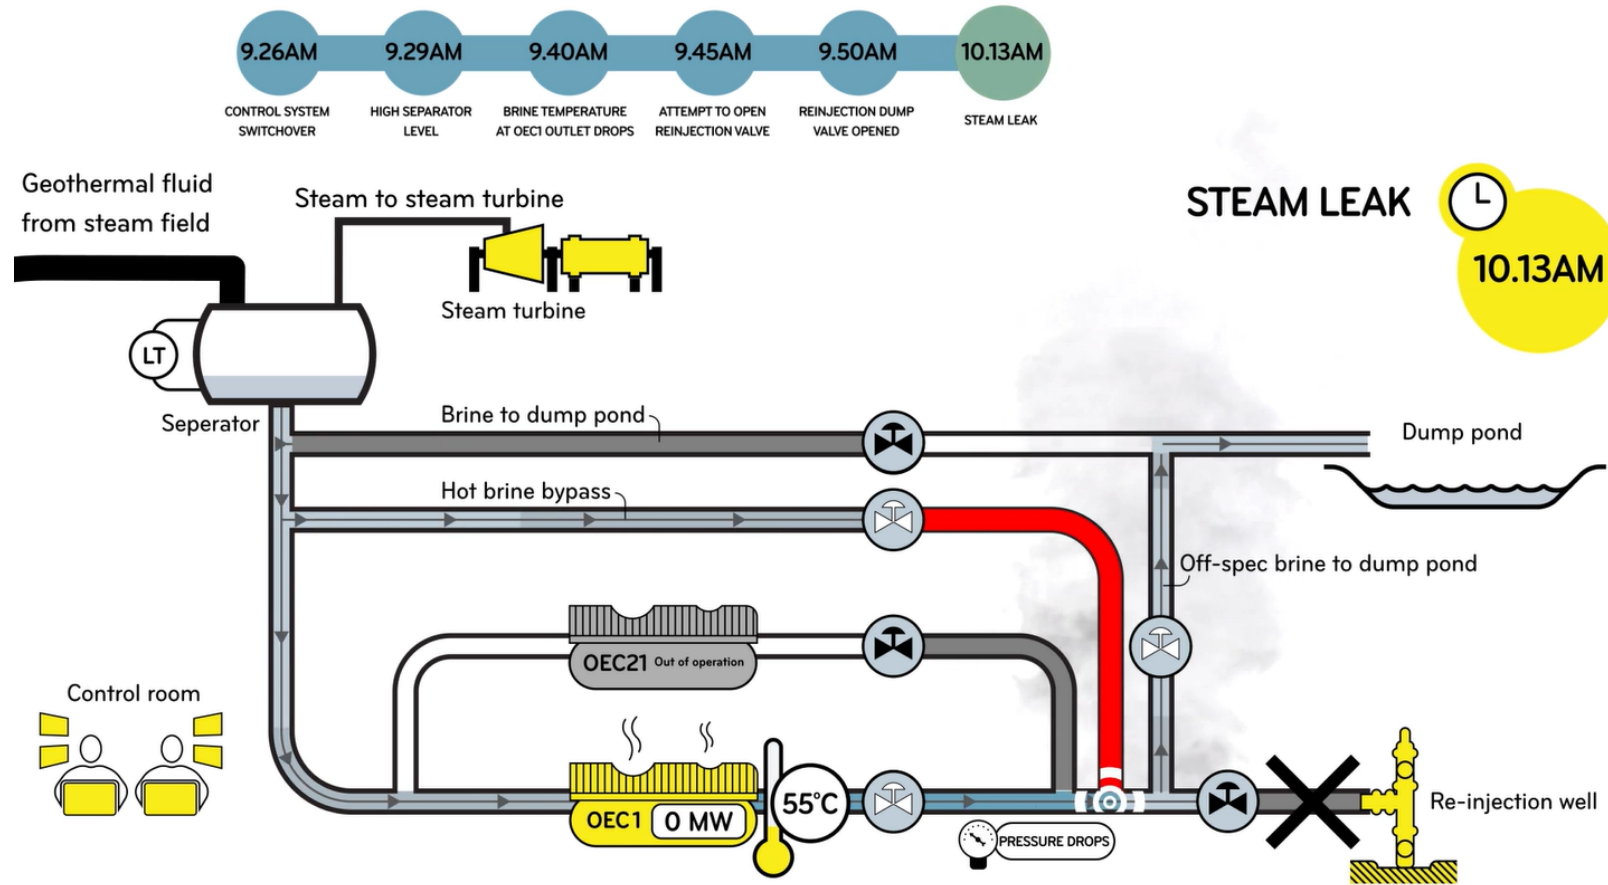
A control system switch over causes the re-injection well control valve to close.

Brine flow stops, causing high separator level.

Hot brine bypass opens fully but is not able to pass fluid.

Brine temperature at OEC1 outlet drops.

Opening of off-spec brine control valve to dump pond reestablishes brine flow and causes backpressure to drop. Hot brine starts to flash.

Mixing of hot steam with subcooled brine leads to ongoing 'Condensation Induced Water Hammer' and piping damage and loss of containment of steam.
