HSE Incident – #299 Steam Burn

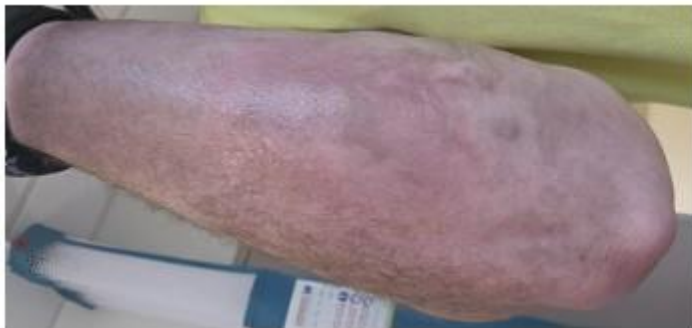
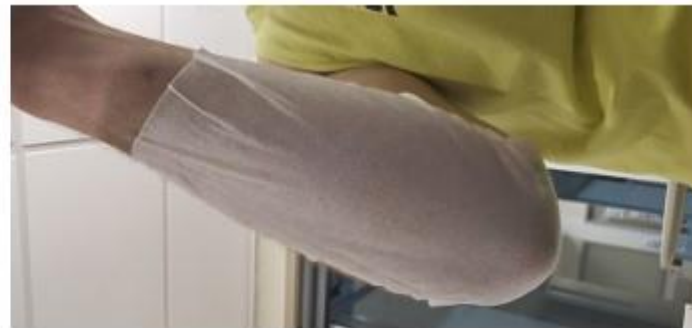
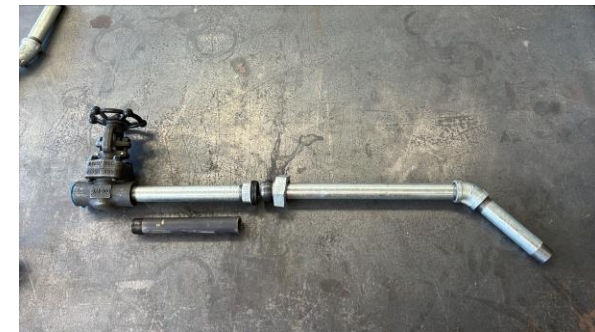
During bleed off, the operator switched hands to turn the valve just as the pressure died off and the steam direction changed. This caused a jet of steam to go directly up his sleeve trapping the heat and causing a burn.

Steam was able to get directed up the operators sleeve as the gloves being worn were not long enough to cover the sleeve cuff on his shirt.

Longer heat resistant gloves should be worn when operating valves during bleed offs. These gloves would cover the cuffs which would stop steam being able to travel up a sleeve. An engineered pipe with elbow would be able to direct the steam away from the operator.

Alter procedures and SOPs to include the use of longer heat resistant gloves for bleed off procedures and engineer an elbow and pipe with adjustable extension and mac union connection to direct steam away from the operator during bleed offs.
