Safety alert

Injury caused by dropped object

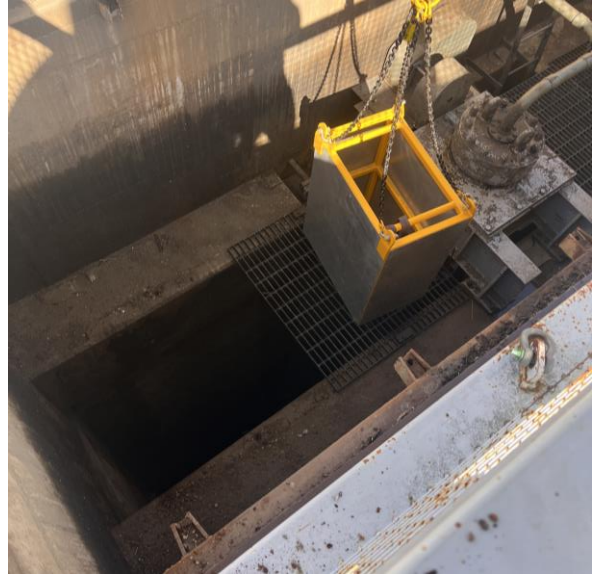
Workers were working down in the headgate of the dam, about 10M below the surface of the dam deck in an open cavity. Tools are lowered by rope down to the work crew as required by personnel on the dam deck. The work crew on the headgate moved back to the far side of the gate from the tool bag as it was being lowered. As the tool bag was lowered over the edge, a spanner, about 400mm long and weighing approx 4kg became dislodged from the bag and fell approx 10 metres down to the gate. As it fell it hit the wall and bounced a couple of times and then landed on the top of the gate where it bounced up and hit a staff member on the knee and then on the head. He was wearing his hard hat which protected his head. His knee was bruised but he was able to climb up the ladder to get out unaided. He was taken to the medical centre as a precaution and went home. He returned to work the next day.

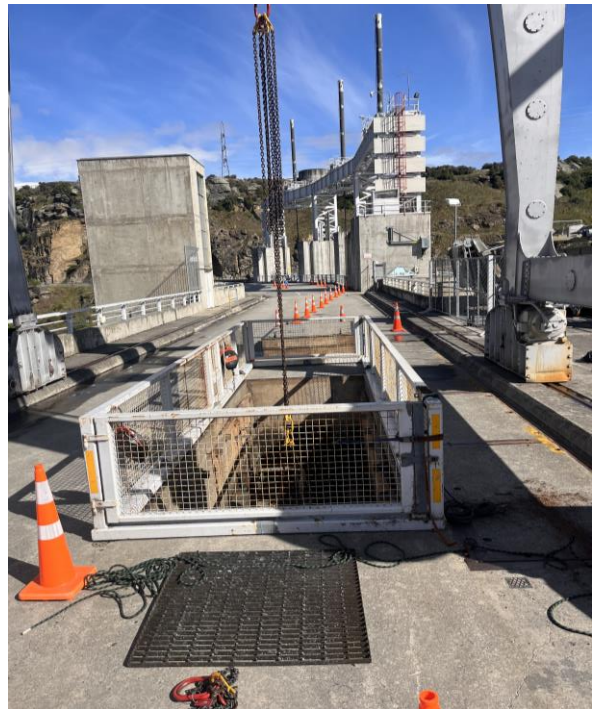
Just as the toolbag was being lowered, a team member made a decision to reach for a tool out of the bag for a job he was doing on the dam deck. It caught on the spanner, which caused the spanner to drop. The toolbag was not fastened at the top.

The safety paperwork for this job did not cover dropped object exclusion zones (the workers on the headgate just made a good call to stand back, away from the toolbag), and procedure did not cover toolbag fastening.

Not standing under, or near a suspended load in this instance could have saved a life. The drops calculator indicates this force (4kg x 10metres) was strong enough to penetrate a hard hat, and we now understand the force considering the bounce impact it had (causing injury).

Procedure and hazard ID for work such as this should have indicated dropped object hazards and mitigations, such as toolbag fastening, exclusion zones, tool lanyards for workers, and good work practice (not touching a suspended load).
